Manhole Inspection Summary

Manhole # S05AA2003MH

Inspection ☐ Is Incomplete Rating: **4) Poor**

Location Address: **3106 PARKINGTON AVE**

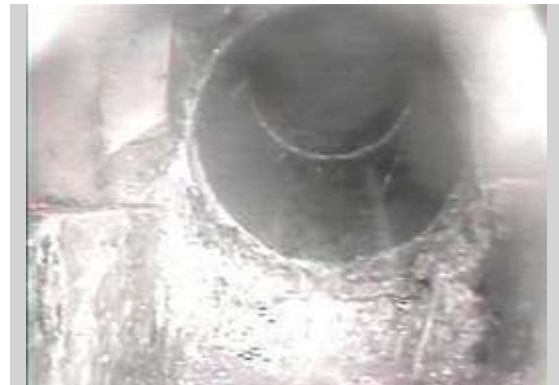
Drop In @ 3 O'Clock

Drop: **Outside** Rod and Bar
Angled: **Yes** Reading: **11.43** (ft.)
Inv Depth: **12.43** (ft.)

Drop Condition: **Open**
